# PALZIV NORTH AMERICA ACOUSTICAL PERFORMANCE TEST REPORT

ASTM E90, ASTM E492, AND ASTM E2179 TESTING ON LIFEPROOF PLUSH CARPET OVER 8MM (5/16") HQ LIVING CARPET CUSHION

Concrete Slab - 152 mm

M5263.13-113-11-R0

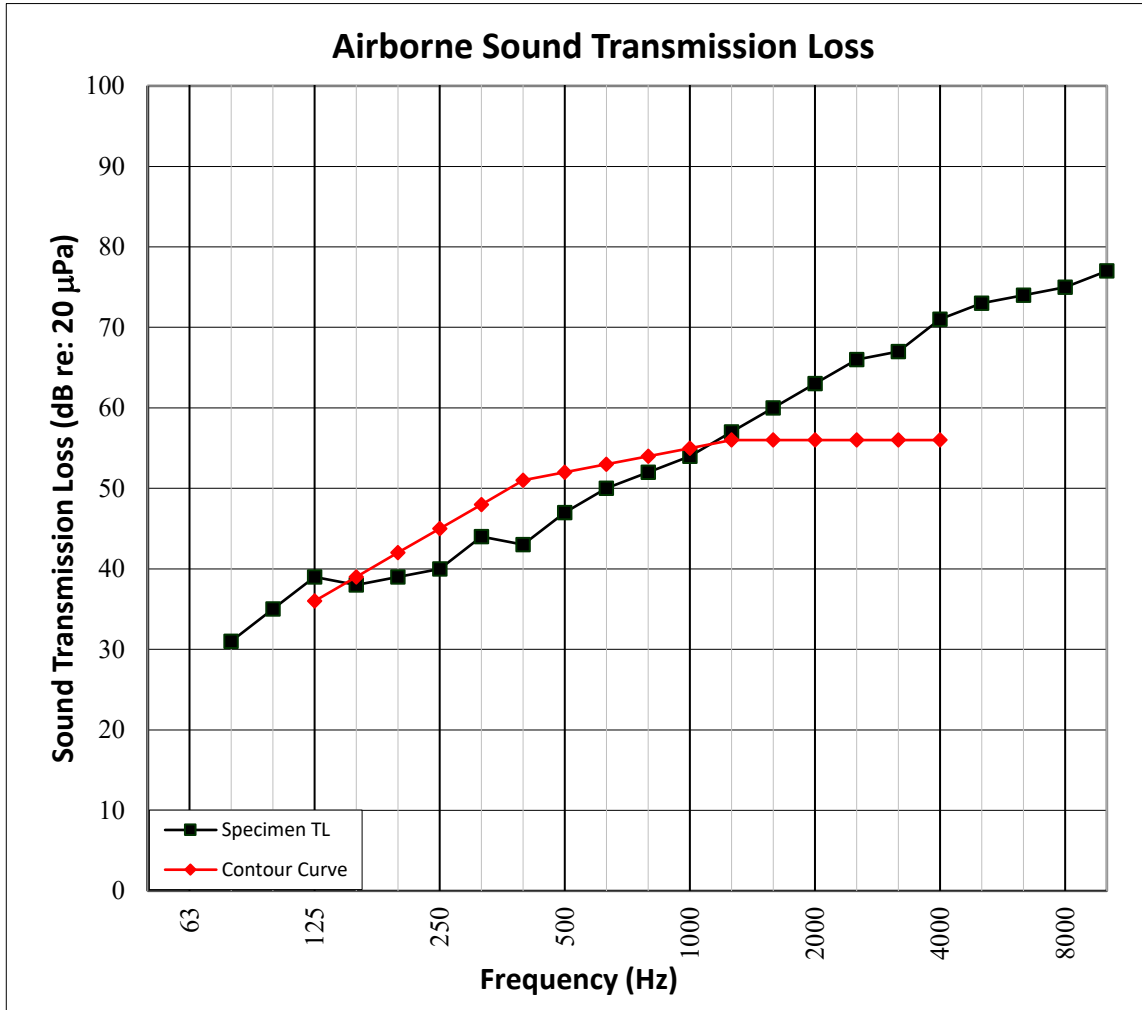
#### TEST RESULTS - AIRBORNE SOUND TRANSMISSION LOSS GRAPH

<b>TEST DATE</b>	6/19/2021				
<b>DATA FILE NO.</b>	M5263.13				
<b>CLIENT</b>	Palziv North America				
<b>DESCRIPTION</b>	16 mm Lifeproof Plush Carpet, 8 mm (5/16") HQ Living Foam Carpet Cushion, 152.4 mm 5000 PSI Concrete Slab				
<b>SPECIMEN AREA</b>	10.98 m <sup>2</sup>	<b>Receive Temp.</b>	22.4°C	<b>Source Temp.</b>	23.7°C
<b>TECHNICIAN</b>	MAU	<b>Receive Humidity</b>	62%	<b>Source Humidity</b>	62%

FREQ (Hz)	BACKGROUND SPL (dB)	ABSORPTION m <sup>2</sup>	SOURCE SPL (dB)	RECEIVE SPL (dB)	SPECIMEN TL (dB)	95% CONFIDENCE LIMIT	NUMBER OF DEFICIENCIES
80	31.5	14.7	95	64	31	3.4	-
100	29.0	10.7	94	60	35	2.5	-
125	32.8	10.7	94	56	39	2.4	0
160	33.6	10.9	94	57	38	1.0	1
200	23.0	13.4	94	54	39	1.2	3
250	21.8	12.0	98	58	40	1.2	5
315	23.8	11.5	101	57	44	1.1	4
400	18.5	10.5	101	58	43	0.7	8
500	12.4	10.1	100	53	47	0.7	5
630	17.7	10.2	102	52	50	1.1	3
800	18.7	10.1	100	49	52	0.7	2
1000	15.1	10.3	99	46	54	0.7	1
1250	12.6	10.6	99	43	57	0.7	0
1600	8.2	10.7	100	40	60	0.9	0
2000	6.5	11.3	99	36	63	0.7	0
2500	5.9	12.0	98	33	66	0.6	0
3150	5.0	12.5	99	31	67	0.6	0
4000	5.5	13.6	100	28	71	0.5	0
5000	6.1	15.4	100	26	73	0.6	-
6300	7.1	17.9	95	19	74	0.7	-
8000	7.4	22.3	94	16	75	1.2	-
10000	7.9	22.3	91	12	77	1.1	-
<b>STC Rating</b>	<b>52</b>	<i>(Sound Transmission Class)</i>			<b>Sum of Deficiencies</b>	<b>32</b>

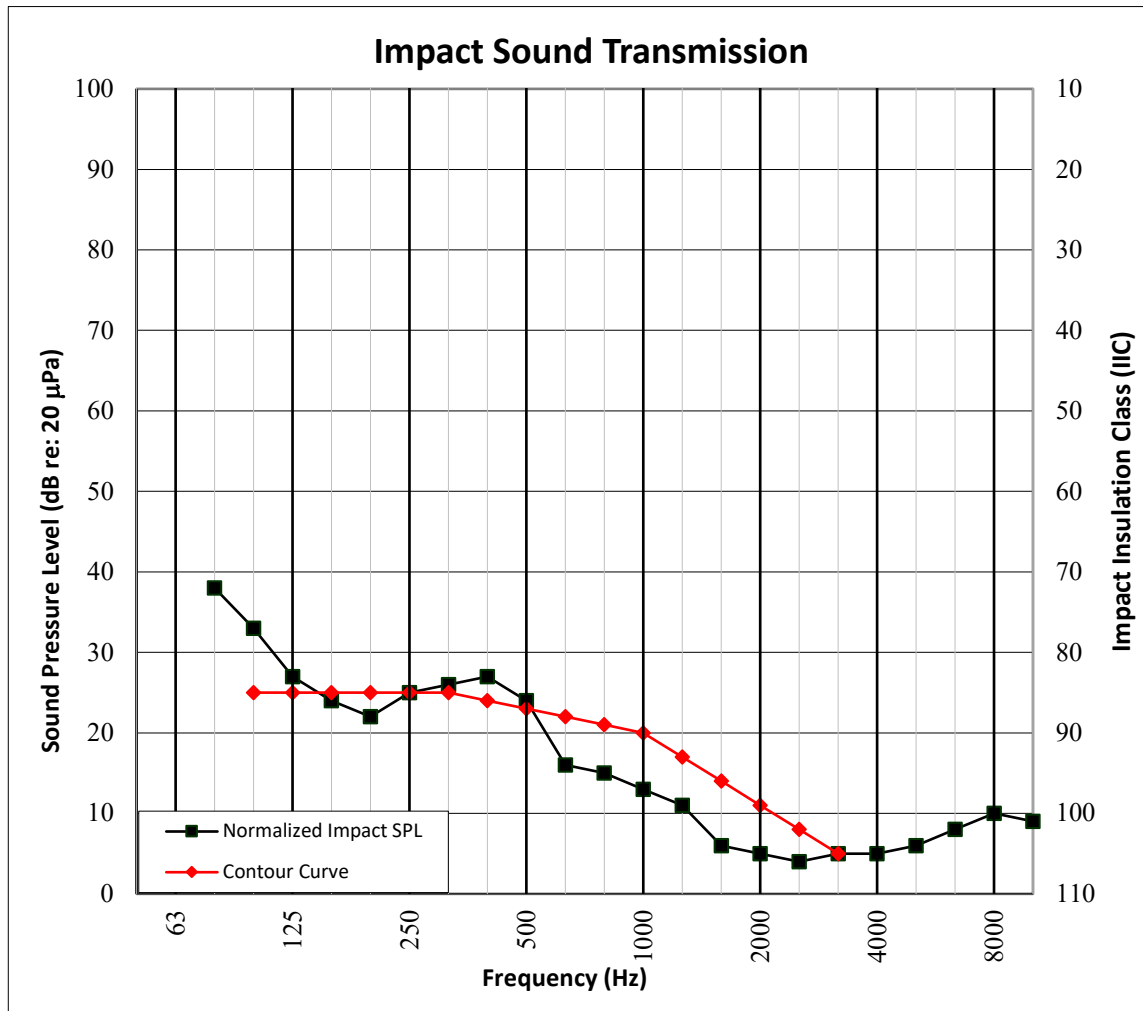
#### TEST RESULTS - IMPACT SOUND TRANSMISSION GRAPH

<b>TEST DATE</b>	6/19/2021				
<b>DATA FILE NO.</b>	M5263.13				
<b>CLIENT</b>	Palziv North America				
<b>DESCRIPTION</b>	16 mm Lifeproof Plush Carpet, 8 mm (5/16") HQ Living Foam Carpet Cushion, 152.4 mm 5000 PSI Concrete Slab				
<b>SPECIMEN AREA</b>	10.98 m <sup>2</sup>	<b>Maximum Temp.</b>	22.4°C	<b>Minimum Temp.</b>	22.3°C
<b>TECHNICIAN</b>	MAU	<b>Max. Humidity</b>	62%	<b>Min. Humidity</b>	61%

FREQ (Hz)	BACKGROUND SPL (dB)	ABSORPTION m <sup>2</sup>	NORMALIZED IMPACT SPL (dB)	95% CONFIDENCE LIMIT	NUMBER OF DEFICIENCIES
80	29.1	14.9	38	2.5	-
100	31.5	12.7	33	1.4	8
125	23.2	10.4	27	1.0	2
160	19.2	10.3	24	0.9	0
200	16.4	13.5	22	0.6	0
250	19.3	11.8	25	0.6	0
315	15.1	11.5	26	0.5	1
400	12.9	10.4	27	0.5	3
500	8.4	10.0	24	0.5	1
630	12.8	10.4	16	0.4	0
800	15.5	10.3	15	0.3	0
1000	12.1	10.5	13	0.6	0
1250	10.2	10.6	11	0.4	0
1600	6.8	10.7	6	0.3	0
2000	6.0	11.3	5	0.3	0
2500	5.9	12.1	4	0.4	0
3150	5.0	12.5	5	0.3	0
4000	5.3	13.7	5	0.3	-
5000	6.1	15.3	6	0.2	-
6300	7.0	17.7	8	0.2	-
8000	7.3	22.1	10	0.2	-
10000	7.5	22.1	9	0.2	-
<b>IIC Rating</b>	<b>87</b>	<i>(Impact Insulation Class)</i>		<b>Sum of Deficiencies</b>	<b>15</b>

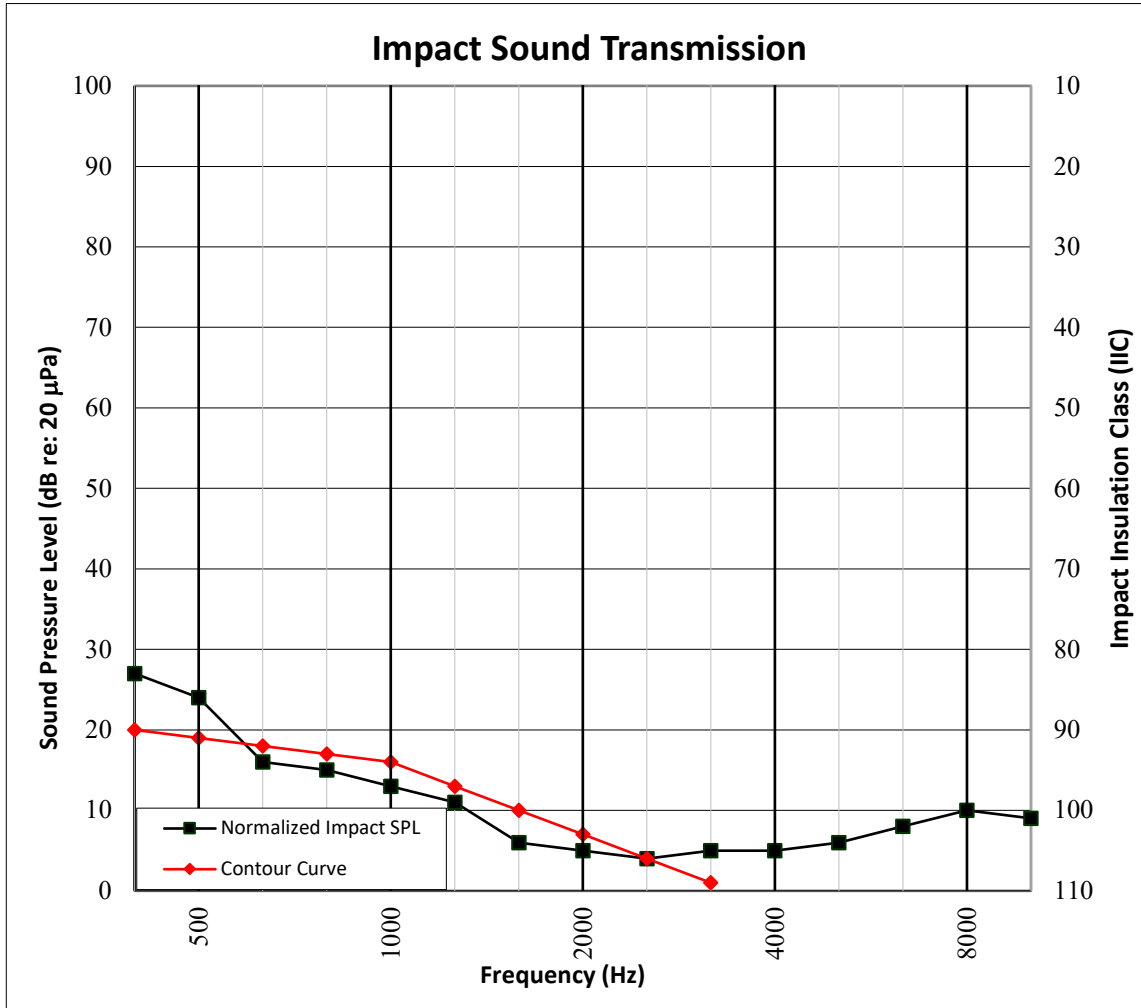
#### TEST RESULTS -HIGH-FREQUENCY IMPACT SOUND TRANSMISSION GRAPH

<b>TEST DATE</b>	6/19/2021				
<b>DATA FILE NO.</b>	M5263.13				
<b>CLIENT</b>	Palziv North America				
<b>DESCRIPTION</b>	16 mm Lifeproof Plush Carpet, 8 mm (5/16") HQ Living Foam Carpet Cushion, 152.4 mm 5000 PSI Concrete Slab				
<b>SPECIMEN AREA</b>	10.98 m <sup>2</sup>	<b>Maximum Temp.</b>	22.4°C	<b>Minimum Temp.</b>	22.3°C
<b>TECHNICIAN</b>	MAU	<b>Max. Humidity</b>	62%	<b>Min. Humidity</b>	61%

FREQ (Hz)	BACKGROUND SPL (dB)	ABSORPTION m <sup>2</sup>	NORMALIZED IMPACT SPL (dB)	95% CONFIDENCE LIMIT	NUMBER OF DEFICIENCIES
400	12.9	10.4	27	0.5	7.1
500	8.4	10.0	24	0.5	4.8
630	12.8	10.4	16	0.4	0.0
800	15.5	10.3	15	0.3	0.0
1000	12.1	10.5	13	0.6	0.0
1250	10.2	10.6	11	0.4	0.0
1600	6.8	10.7	6	0.3	0.0
2000	6.0	11.3	5	0.3	0.0
2500	5.9	12.1	4	0.4	0.5
3150	5.0	12.5	5	0.3	3.6
<b>HIIC Rating</b>	<b>91</b>	<i>(High-Frequency Impact Insulation Class)</i>		<b>Sum of Deficiencies</b>	<b>16.0</b>

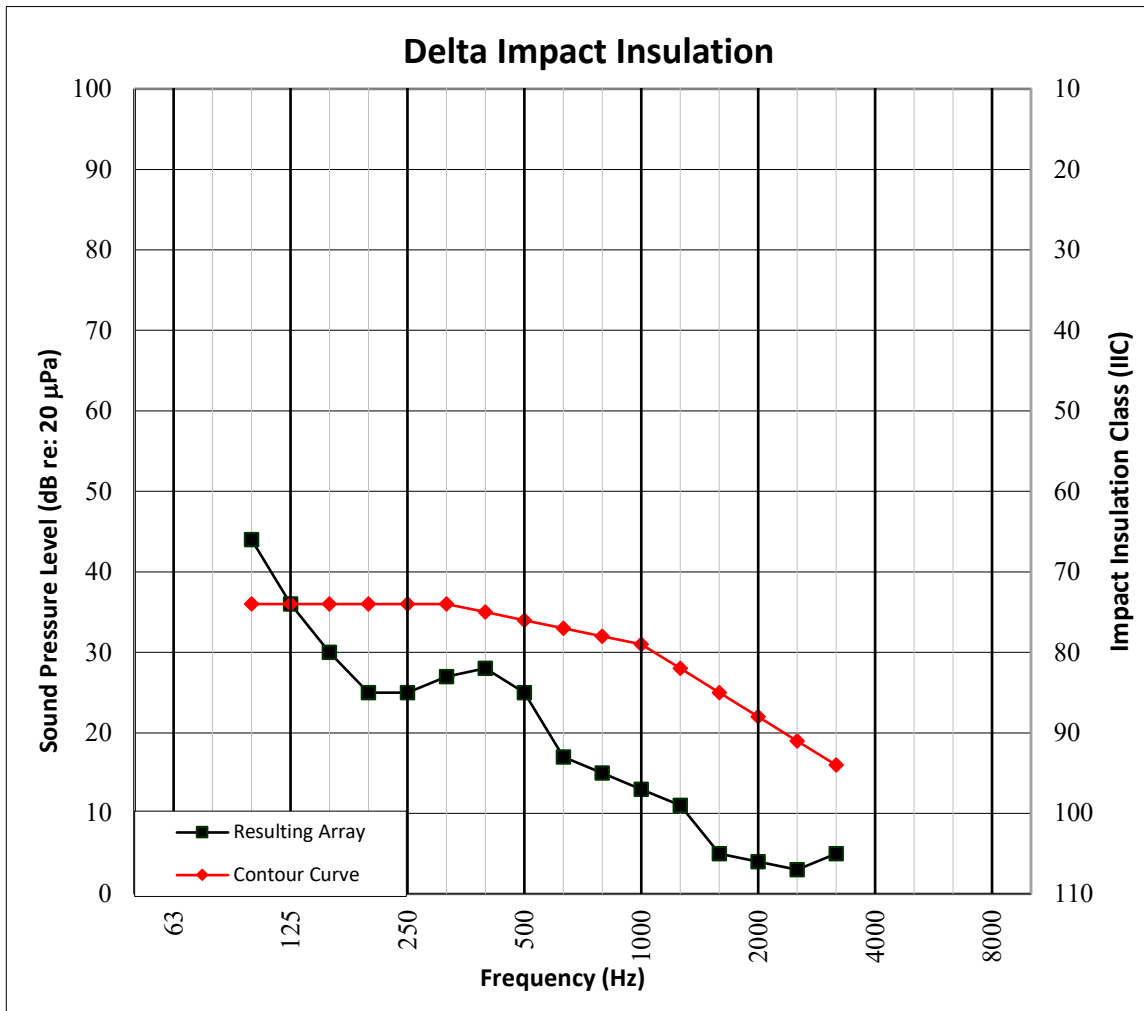
#### TEST RESULTS - DELTA IMPACT INSULATION GRAPH

<b>TEST DATE</b>	6/19/2021				
<b>DATA FILE NO.</b>	M5263.13				
<b>CLIENT</b>	Palziv North America				
<b>DESCRIPTION</b>	16 mm Lifeproof Plush Carpet, 8 mm (5/16") HQ Living Foam Carpet Cushion, 152.4 mm 5000 PSI Concrete Slab				
<b>SPECIMEN AREA</b>	10.98 m <sup>2</sup>	<b>Maximum Temp.</b>	22.4°C	<b>Minimum Temp.</b>	22.3°C
<b>TECHNICIAN</b>	MAU	<b>Max. Humidity</b>	62%	<b>Min. Humidity</b>	61%

FREQ (Hz)	BACKGROUND SPL (dB)	ABSORPTION m <sup>2</sup>	NORMALIZED IMPACT SPL BARE (dB)	95% CONF LIMIT	NORMALIZED IMPACT SPL SPEC (dB)	95% CONF LIMIT	RESULT ARRAY L <sub>ref,c</sub>	NUMBER OF DEFICIENCIES
100	31.5	12.7	55.9	1.4	32.6	1.7	44.0	8
125	23.2	10.4	59.2	1.3	27.4	1.2	36.0	0
160	19.2	10.3	61.8	0.9	23.6	1.1	30.0	0
200	16.4	13.5	65.6	0.7	22.0	0.7	25.0	0
250	19.3	11.8	68.5	1.0	24.5	0.8	25.0	0
315	15.1	11.5	68.8	0.7	25.9	0.6	27.0	0
400	12.9	10.4	69.1	0.6	27.1	0.7	28.0	0
500	8.4	10.0	69.2	0.7	23.8	0.7	25.0	0
630	12.8	10.4	70.3	0.5	16.2	0.5	17.0	0
800	15.5	10.3	71.6	0.6	14.7	0.4	15.0	0
1000	12.1	10.5	71.8	0.3	13.0	0.7	13.0	0
1250	10.2	10.6	72.1	0.4	10.6	0.5	11.0	0
1600	6.8	10.7	73.0	0.4	6.1	0.4	5.0	0
2000	6.0	11.3	73.1	0.7	4.7	0.3	4.0	0
2500	5.9	12.1	73.0	0.8	4.5	0.5	3.0	0
3150	5.0	12.5	71.7	0.9	4.6	0.4	5.0	0
<b>ΔIIC Rating</b>	<b>48</b>	<i>(Delta Impact Insulation Class)</i>				<b>Sum of Deficiencies</b>	<b>8</b>

<b>ΔHIIC Rating</b>	<b>63</b>	<i>(Delta High-Frequency Impact Insulation Class)</i>				<b>Sum of Deficiencies</b>	<b>18</b>

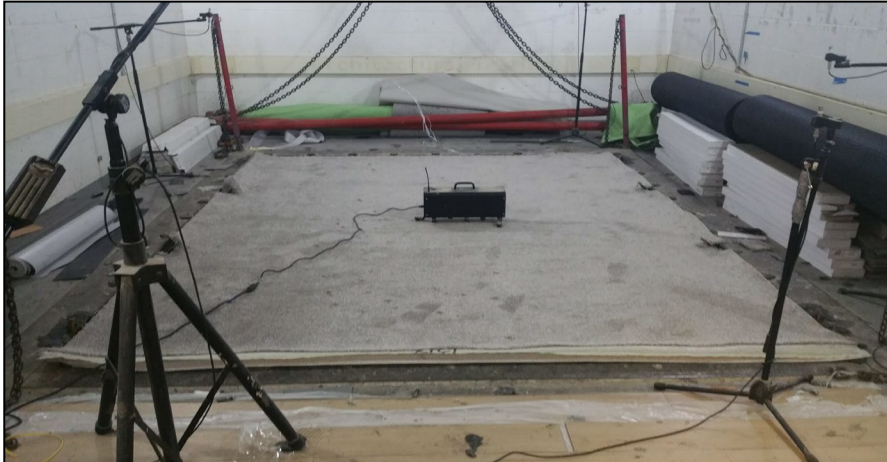
**Photo No. 1**  
**Source Room View of Test Specimen Installation**

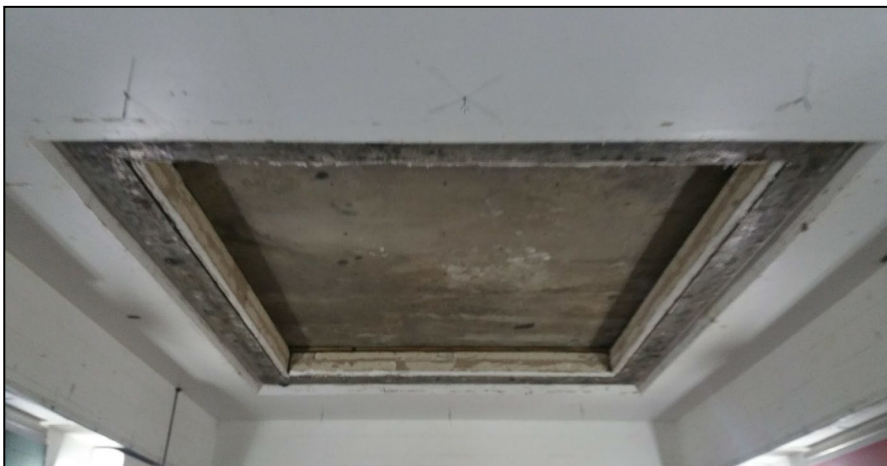
**Photo No. 2**  
**Receive Room View of Test Specimen Installation**
