# PALZIV NORTH AMERICA ACOUSTICAL PERFORMANCE TEST REPORT

ASTM E90 AND ASTM E492 TESTING ON LIFEPROOF PLUSH CARPET OVER 11MM (7/16") HQ LIVING CARPET CUSHION

152 mm Concrete Slab with Suspended Ceiling

M5263.16-113-11-R0

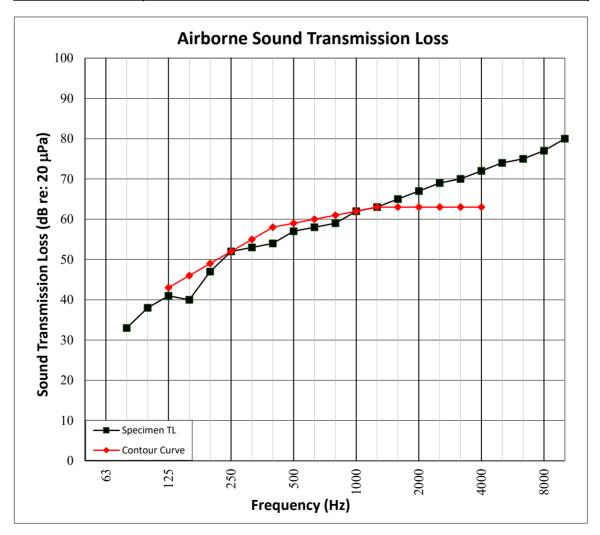
## **TEST RESULTS - AIRBORNE SOUND TRANSMISSION LOSS GRAPH**

DATA FILE NO. CLIENT DESCRIPTION	16 mm Lifeproof Plu Concrete Slab, 43 m Tee, 88.9 mm Johns	·					
SPECIMEN AREA	10.98 m²	Receive Temp.	21°C	Source Temp.	22.2°C		
TECHNICIAN	MAU	Receive Humidity	69%	Source Humidity	69%

TEST DATE	6/19/2021							
DATA FILE NO.	M5263.16				ACCREDITED			
CLIENT	Palziv North Am	alziv North America						
DESCRIPTION	Concrete Slab, 43 m Tee, 88.9 mm Johns	mm Lifeproof Plush Carpet, 11 mm (7/16") HQ Living Foam Carpet Cushion , 152.4 mm 5000 PSI ncrete Slab, 43 mm Armstrong HD8906 Drywall Main Beam, 37.3 mm Armstrong XL8945P Cross e, 88.9 mm Johns Manville Unfaced R-13 Fiberglass Insulation, 15.9 mm National Gypsum Gold nd® Fire-Shield® Type X Gypsum Panel						
SPECIMEN AREA	10.98 m²	Receive Temp.	21°C	Source Temp.	22.2°C			
TECHNICIAN	MAU	Receive Humidity	69%	<b>Source Humidity</b>	69%

FREQ	BACKGROUND	ABSORPTION	SOURCE	RECEIVE	SPECIMEN	95%	NUMBER
FREQ	SPL	ABSORPTION	SPL	SPL	TL	CONFIDENCE	OF
(Hz)	(dB)	m²	(dB)	(dB)	(dB)	LIMIT	DEFICIENCIES
80	30.8	16.5	97	63	33	3.4	-
100	25.2	8.7	94	58	38	2.1	-
125	26.8	10.8	95	55	41	2.4	2
160	22.5	11.1	93	55	40	1.4	6
200	18.7	11.7	94	48	47	1.1	2
250	19.4	11.4	99	47	52	1.1	0
315	16.3	11.6	101	49	53	1.2	2
400	13.5	10.0	102	49	54	0.6	4
500	13.1	9.1	99	44	57	0.6	2
630	12.6	8.9	101	44	58	0.6	2
800	13.5	9.0	100	42	59	0.6	2
1000	13.2	9.2	99	39	62	0.6	0
1250	9.4	9.1	100	38	63	0.7	0
1600	5.9	9.4	100	35	65	0.6	0
2000	5.1	10.1	99	33	67	0.7	0
2500	4.9	11.3	98	31	69	0.3	0
3150	4.6	12.3	99	29	70	0.7	0
4000	5.1	13.2	100	27	72	0.5	0
5000	5.8	14.6	100	25	74	0.4	-
6300	6.5	17.0	95	19	75	0.7	-
8000	7.1	21.8	95	15	77	1.2	-
10000	7.4	21.8	91	9	80	1.3	-
STC Ratir	1g 59	(Sound Transmi	ssion Class)		Sum o	f Deficiencies	22

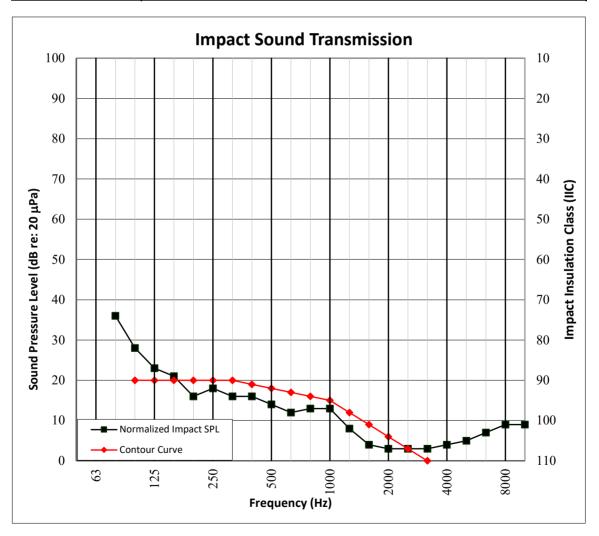
## **TEST RESULTS - IMPACT SOUND TRANSMISSION GRAPH**

TEST DATE  DATA FILE NO.  CLIENT	6/19/2021 M5263.16 Palziv North Am	•						
DESCRIPTION	Concrete Slab, 43 m Tee, 88.9 mm Johns	mm Lifeproof Plush Carpet, 11 mm (7/16") HQ Living Foam Carpet Cushion , 152.4 mm 5000 PSI ncrete Slab, 43 mm Armstrong HD8906 Drywall Main Beam, 37.3 mm Armstrong XL8945P Cross e, 88.9 mm Johns Manville Unfaced R-13 Fiberglass Insulation, 15.9 mm National Gypsum Gold and Fire-Shield Type X Gypsum Panel						
SPECIMEN AREA	10.98 m²	Maximum Temp.	21.6°C	Minimum Temp.	20.4°C			
TECHNICIAN	MAU	Max. Humidity	73%	Min. Humidity	66%

TEST DATE	6/19/2021							
DATA FILE NO.	M5263.16				ACCREDITED			
CLIENT	Palziv North Am	alziv North America						
DESCRIPTION	Concrete Slab, 43 m Tee, 88.9 mm Johns	mm Lifeproof Plush Carpet, 11 mm (7/16") HQ Living Foam Carpet Cushion , 152.4 mm 5000 PSI ncrete Slab, 43 mm Armstrong HD8906 Drywall Main Beam, 37.3 mm Armstrong XL8945P Cross e, 88.9 mm Johns Manville Unfaced R-13 Fiberglass Insulation, 15.9 mm National Gypsum Gold and Fire-Shield Type X Gypsum Panel						
SPECIMEN AREA	10.98 m²	Maximum Temp.	21.6°C	Minimum Temp.	20.4°C			
TECHNICIAN	MAU	Max. Humidity	73%	Min. Humidity	66%

FREQ	BACKGROUND SPL	ABSORPTION	NORMALIZED IMPACT SPL	95% CONFIDENCE	NUMBER OF
(Hz)	(dB)	m²	(dB)	LIMIT	DEFICIENCIES
80	29.1	16.5	36	1.6	DEFICIENCIES
100	23.5	8.8	28	1.3	8
125	22.0	10.4	23	0.8	3
160	22.8	10.4	21	1.2	1
200	16.9	12.3	16	0.8	0
250	18.5	12.1	18	1.8	0
315	17.8	11.5	16	1.1	0
400	14.3	10.0	16	0.8	0
500	14.6	9.0	14	0.8	0
630	16.2	8.9	12	0.7	0
800	15.8	9.1	13	0.8	0
1000	16.9	9.2	13	2.0	0
1250	12.9	9.0	8	0.5	0
1600	8.4	9.2	4	0.4	0
2000	6.4	10.1	3	0.3	0
2500	5.4	11.5	3	0.3	0
3150	4.9	12.1	3	0.2	3
4000	5.4	13.1	4	0.2	-
5000	6.1	14.5	5	0.2	-
6300	11.5	17.1	7	0.2	-
8000	9.6	21.8	9	0.2	-
10000	7.8	21.8	9	0.2	-
IIC Rating	92	(Impact Insulati	on Class)	um of Deficiencies	15

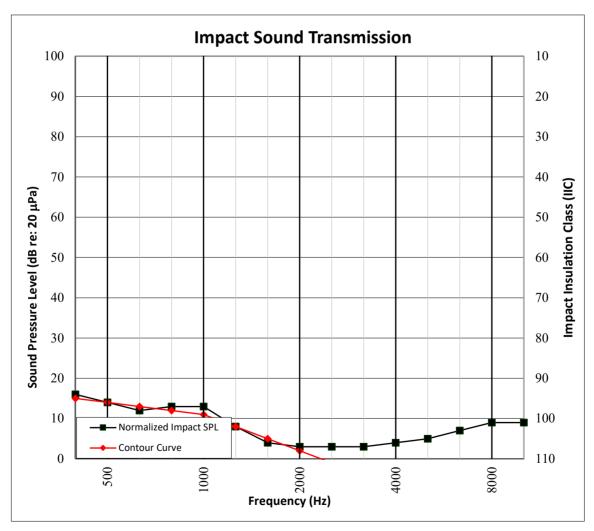
## TEST RESULTS -HIGH-FREQUENCY IMPACT SOUND TRANSMISSION GRAPH

TEST DATE	6/19/2021						
DATA FILE NO.	TA FILE NO. M5263.16						
CLIENT	Palziv North Ar	Palziv North America					
DESCRIPTION	Concrete Slab, 43 r Tee, 88.9 mm John	16 mm Lifeproof Plush Carpet, 11 mm (7/16") HQ Living Foam Carpet Cushion, 152.4 mm 5000 PSI Concrete Slab, 43 mm Armstrong HD8906 Drywall Main Beam, 37.3 mm Armstrong XL8945P Cross Tee, 88.9 mm Johns Manville Unfaced R-13 Fiberglass Insulation, 15.9 mm National Gypsum Gold Bond® Fire-Shield® Type X Gypsum Panel					
SPECIMEN AREA	10.98 m²	Maximum Temp.	21.6°C	Minimum Temp.	20.4°C		
TECHNICIAN	MAU	Max. Humidity	73%	Min. Humidity	66%

TEST DATE	6/19/2021							
DATA FILE NO.	M5263.16				ACCREDITED			
CLIENT	Palziv North Am	Iziv North America						
DESCRIPTION	Concrete Slab, 43 m Tee, 88.9 mm Johns	mm Lifeproof Plush Carpet, 11 mm (7/16") HQ Living Foam Carpet Cushion , 152.4 mm 5000 PSI ncrete Slab, 43 mm Armstrong HD8906 Drywall Main Beam, 37.3 mm Armstrong XL8945P Cross e, 88.9 mm Johns Manville Unfaced R-13 Fiberglass Insulation, 15.9 mm National Gypsum Gold and Fire-Shield Type X Gypsum Panel						
SPECIMEN AREA	10.98 m²	Maximum Temp.	21.6°C	Minimum Temp.	20.4°C			
TECHNICIAN	MAU	Max. Humidity	73%	Min. Humidity	66%

FREQ	BACKGROUND SPL	ABSORPTION	NORMALIZED IMPACT SPL	95% CONFIDENCE	NUMBER OF
(Hz)	(dB)	m²	(dB)	LIMIT	DEFICIENCIES
400	14.3	10.0	16	0.8	1.2
500	14.6	9.0	14	0.8	0.0
630	16.2	8.9	12	0.7	0.0
800	15.8	9.1	13	0.8	0.6
1000	16.9	9.2	13	2.0	2.2
1250	12.9	9.0	8	0.5	0.1
1600	8.4	9.2	4	0.4	0.0
2000	6.4	10.1	3	0.3	1.4
2500	5.4	11.5	3	0.3	4.4
3150	4.9	12.1	3	0.2	7.3
HIIC Ratir	<mark>ng</mark> 96	(High-Frequency	/ Impact Insulation Class)	Sum of Deficiencies	17.3

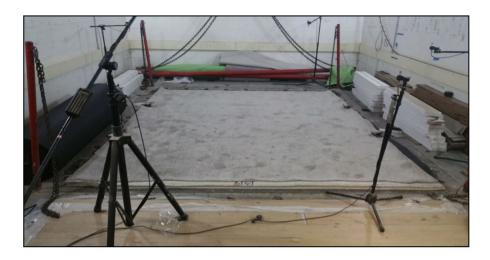
Photo No. 1 Source Room View of Test Specimen Installation

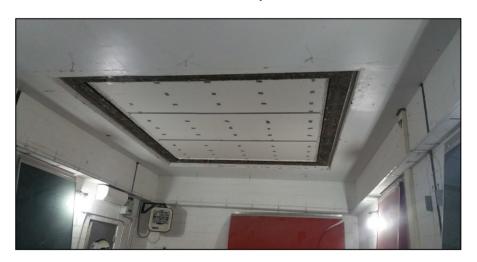
Photo No. 2
Receive Room View of Test Specimen Installation

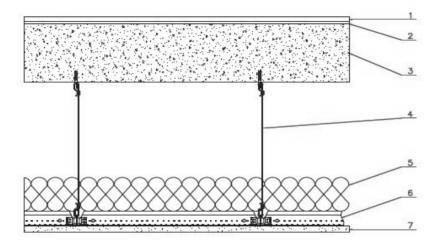
## **DRAWING**

- 1-Floor Topping
- 2-Underlayment
- 3-Concrete Slab
- 4-Hanger Wire
- 5-Insulation
- 6-Ceiling Grid
- 7-Ceiling

MATERIAL	DIMENSIONS (mm)	THICKNESS (mm)	MANUFACTURER AND SERIES	QUANTITY	AVERAGE WEIGHT				
Cornet	3048 by 3657.6	16.0	Lifeproof Plush	10.98 m²	2.69 kg/m <sup>2</sup>				
Carpet	Note: Loose laid								
Foam Carpet	1282.8 by 3048	11.0	(7/16") HQ Living	10.98 m²	0.59 kg/m²				
Cushion	Note: Loose laid			•	•				
	3023 by 3632	152.4	5000 PSI	10.98 m²	366.18 kg/m²				
Concrete Slab	25.4 mm from bo	Note: Installed in a test frame flush to the source room. Mats of #5 reinforcing bars were placed 25.4 mm from both the top and bottom of the slab, with bars spaced on 305 mm centers in both directions. No noticeable shrinkage or cracking was visible on the specimen.

38.1 by 2870	43.0	Armstrong HD8906	10.9 lin m	0.45 kg/m				
Drywall Main Beam	Note: Twelve gauge hanger wires were attached to the bottom side of the concrete at twelve locations and then to the main beams. The hanger wire was twisted around itself a minimum of three times within 76 mm creating a 305 mm plenum. The measured steel thickness was 0.5 mm.								
_	38.3 by 1219	37.3	Armstrong XL8945P	27.2 lin m	0.45 kg/m				
Cross Tee	Note: Inserted into the main beams on 610 mm centers. The measured steel thickness was 0.5 mm.								
Fiberglass	609.6 by 2438	88.9	Johns Manville Unfaced R- 13	10.98 m²	1.32 kg/m²				
Insulation	Note: Loose laid	Note: Loose laid onto the ceiling grid system							
	3023 by 1219	15.9	National Gypsum Gold Bond® Fire-Shield® Type X	10.56 m²	11.23 kg/m²				
Gypsum Panel	Note: Fastened with 25.4 mm fine thread drywall screws on 305 mm centers. Seams and perimeter sealed with Pecora AC-20® Acoustical Sealant and covered with pressure-sensitive tape.
